A Liner made from plasticised PVC will form folds or wrinkles when two conditions are fulfilled: The liner must have expanded considerably and will also have moved on the pool floor or wall.

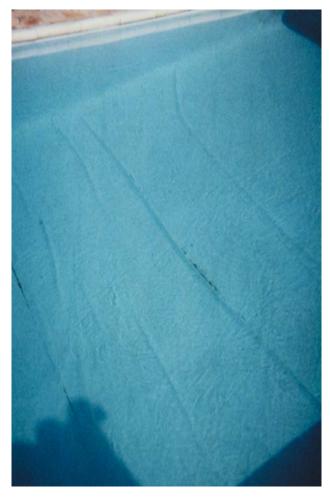
In the picture on the right, the presence of large folds indicates that significant quantities of water are present behind the liner. In effect, the liner is "floating". There may be leaks at the joints between liner and water inlets or outlets, or maybe there is a groundwater problem.

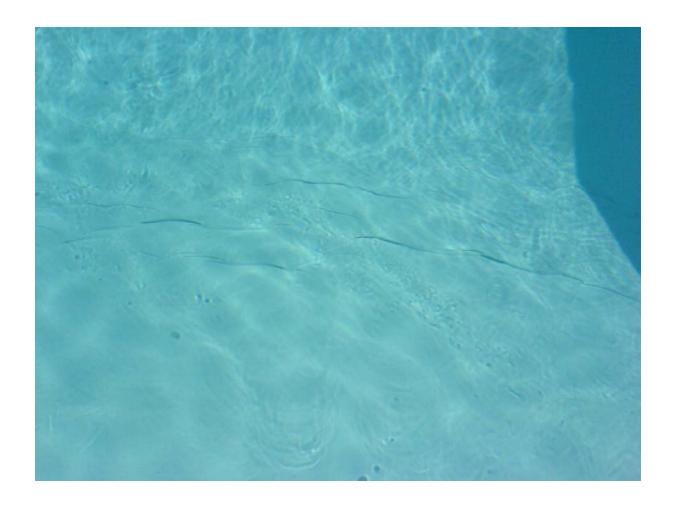
On the picture below, sharp creases are visible. These are a feature of a temporary ground water problem. There had been some kind of water infiltration behind the liner, which has lead to liner displacement and the formation of folds; as the ground water soaks away, the folds are flat and sharp.

Such creases may appear after heavy rain showers. When the immediate area around the pool is flooded, there can be water infiltration between the liner and the pool structure creating a fold. A couple of days later, all this water will have disappeared. The weight of pool water on the liner does not allow the membrane to move back to its original position and without the water behind it the fold collapses leaving a creased liner.

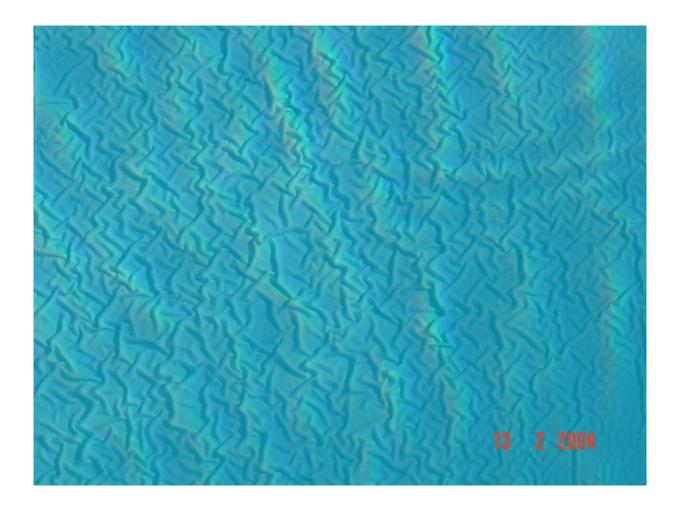
Large folds 30cm or more apart, indicate liner displacement with the presence of water behind the liner. Alternatively, situations, such as the illustration below, can occur where a number of small creases develop much closer together. This indicates that abnormally high moisture absorption has occured, without excessive movement of the liner.

As already stated, a high degree of swelling of the membrane can be caused by high water temperature and/or high levels of chemicals in the pool water. Direct contact between chemicals and the liner is particularly likely to cause this kind of problem.

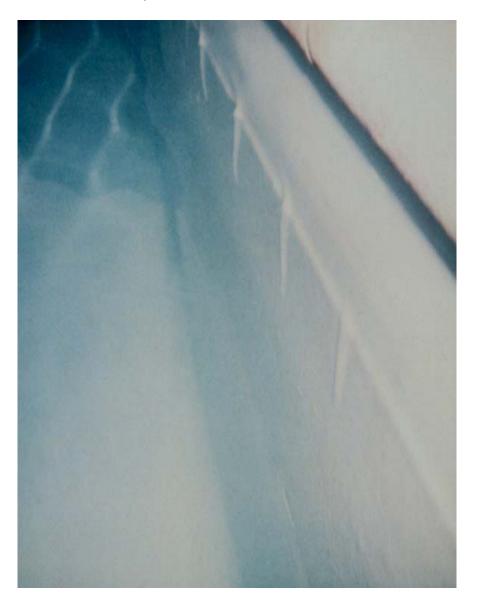
If however the supporting structure is very smooth and waterproof (e.g. plastic or metallic wall panels), this small quantity of humidity will form a slippery film between the liner and the pool structure.

In the picture on the right one can see that the liner material close to the water level (where there is less water pressure) has been able to slip and form vertical folds.
